Department of Water Resources

BULLETIN No. 183-2

# RIVERSIDE COUNTY FLOOD HAZARD INVESTIGATION— MURRIETA CREEK

MAY 1975

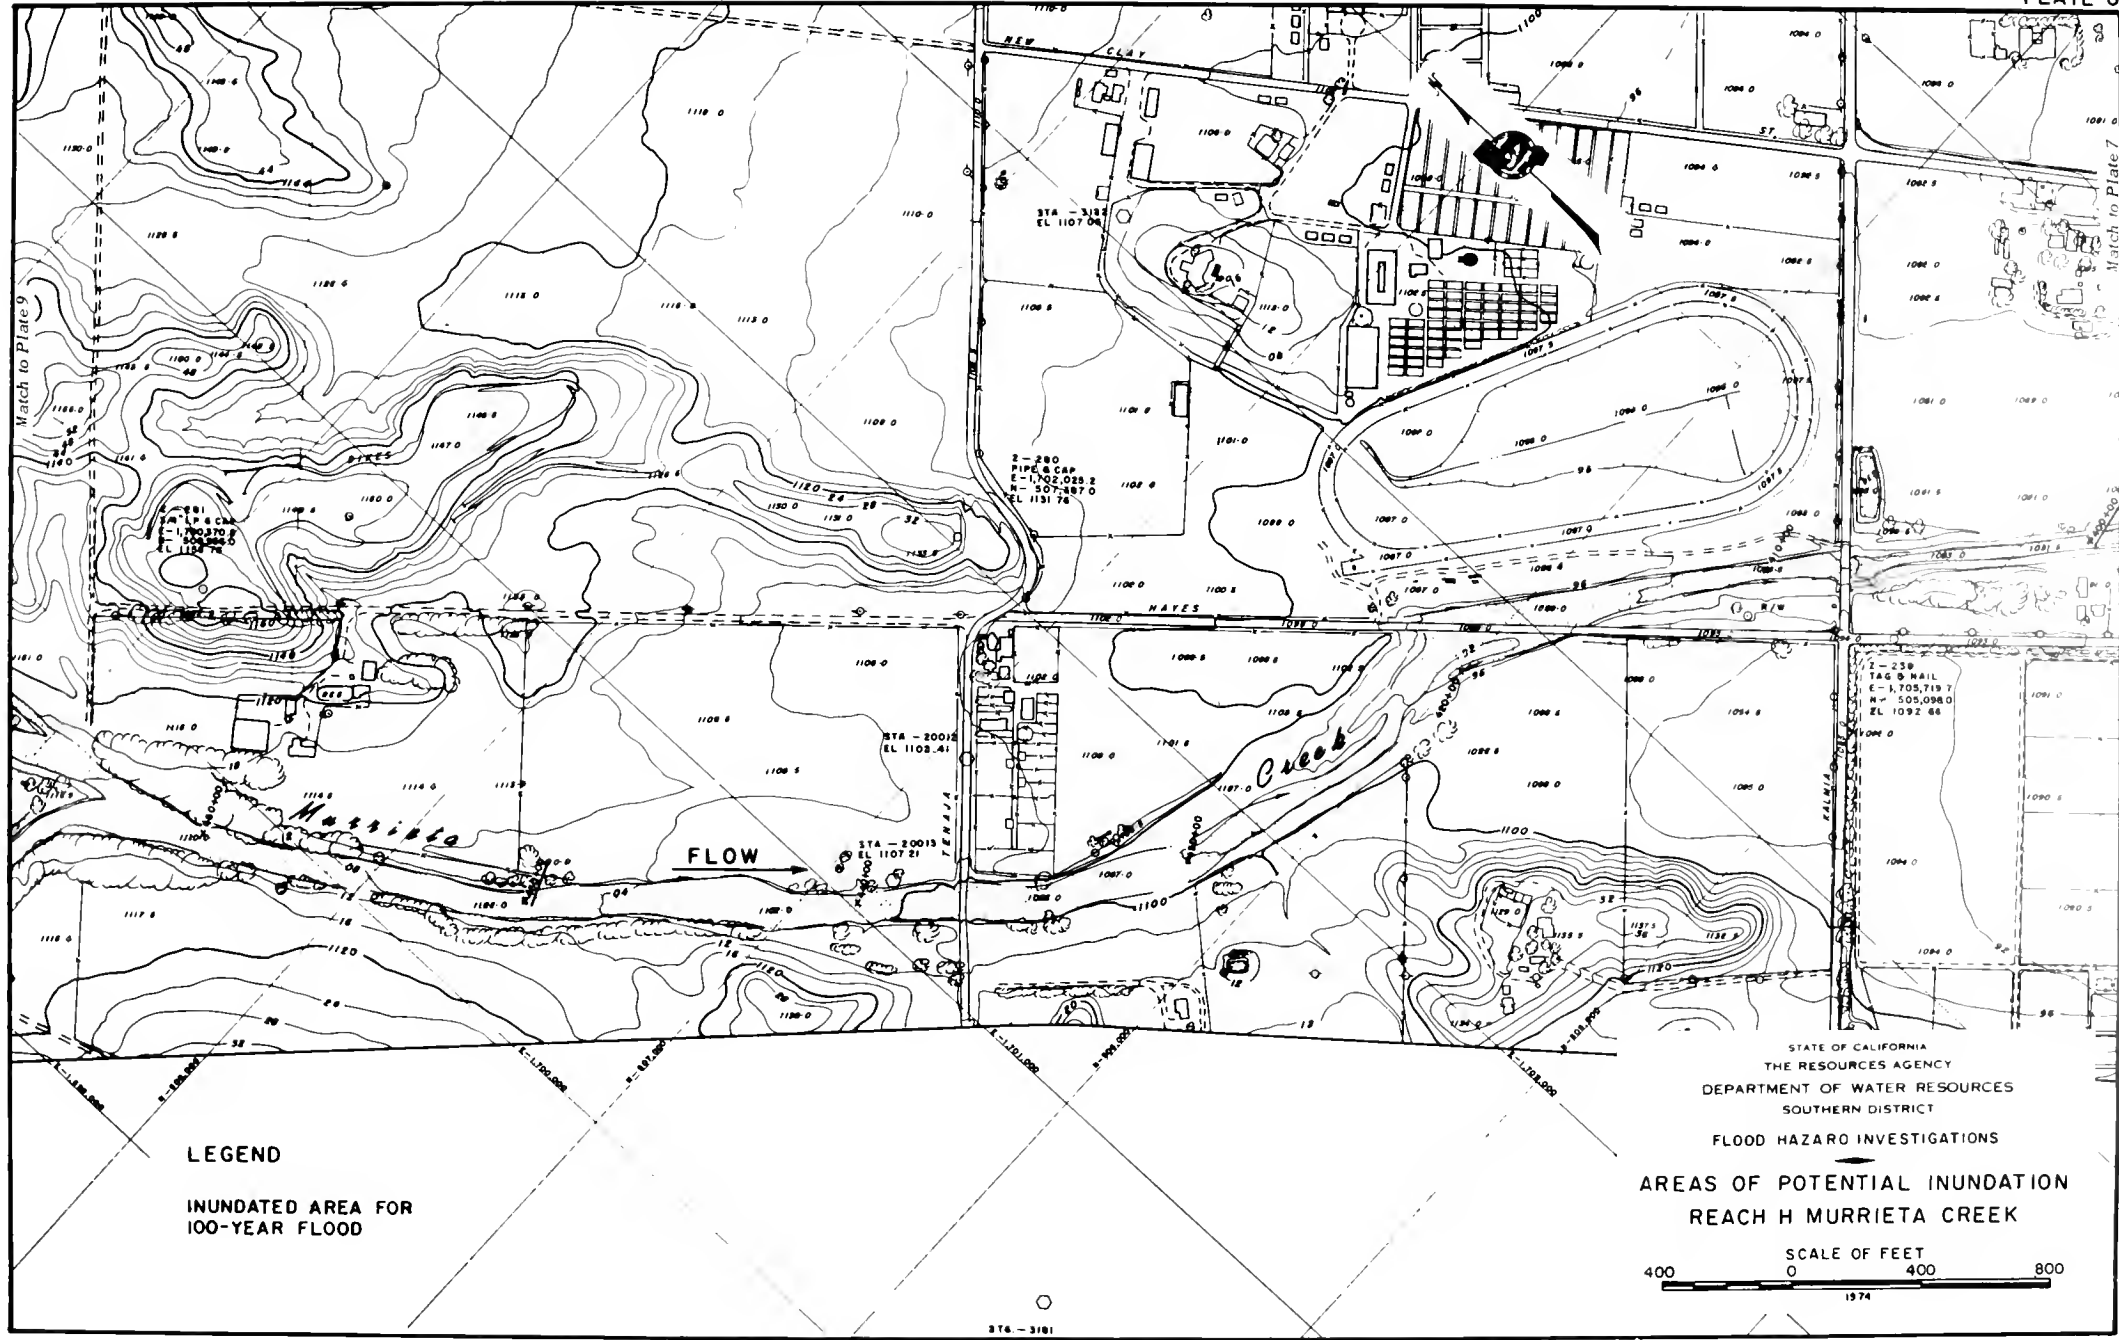
STATE OF CALIFORNIA  
THE RESOURCES AGENCY  
DEPARTMENT OF WATER RESOURCES  
SOUTHERN DISTRICT  
FLOOD HAZARD INVESTIGATIONS  
AREAS OF POTENTIAL INUNDATION  
REACH H MURRIETA CREEK  
SCALE OF FEET  
0 400 800  
1974

The computed water surface elevations were plotted on topographic maps furnished by the District, and the areas of potential inundation were delineated. Plates 1 through 10 show areas subject to flooding along Murrieta Creek and in the community of Temecula, as well as the industrial complex between Main Street and Rancho California Road. Many of the roads would be inundated wholly or in part with some overtopping of the bridge crossings at Main Street and Rancho California Road.

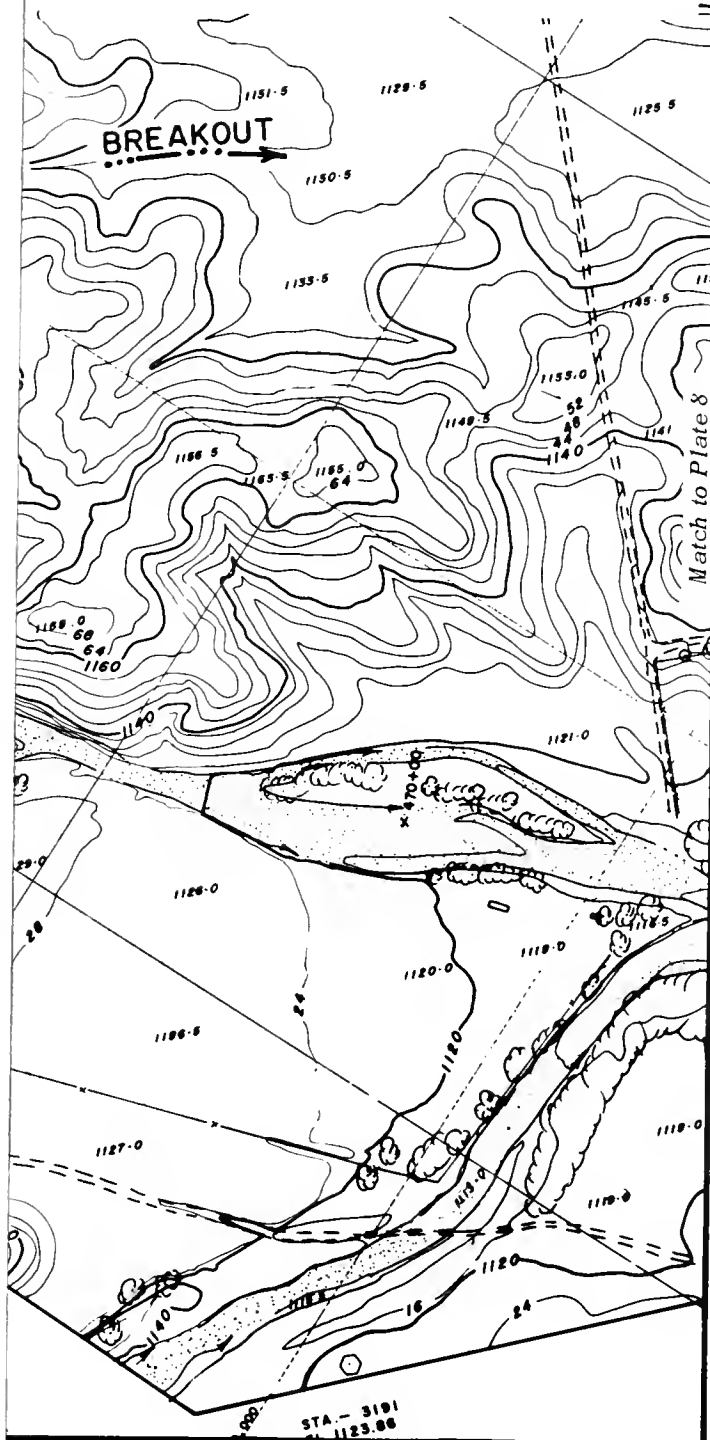
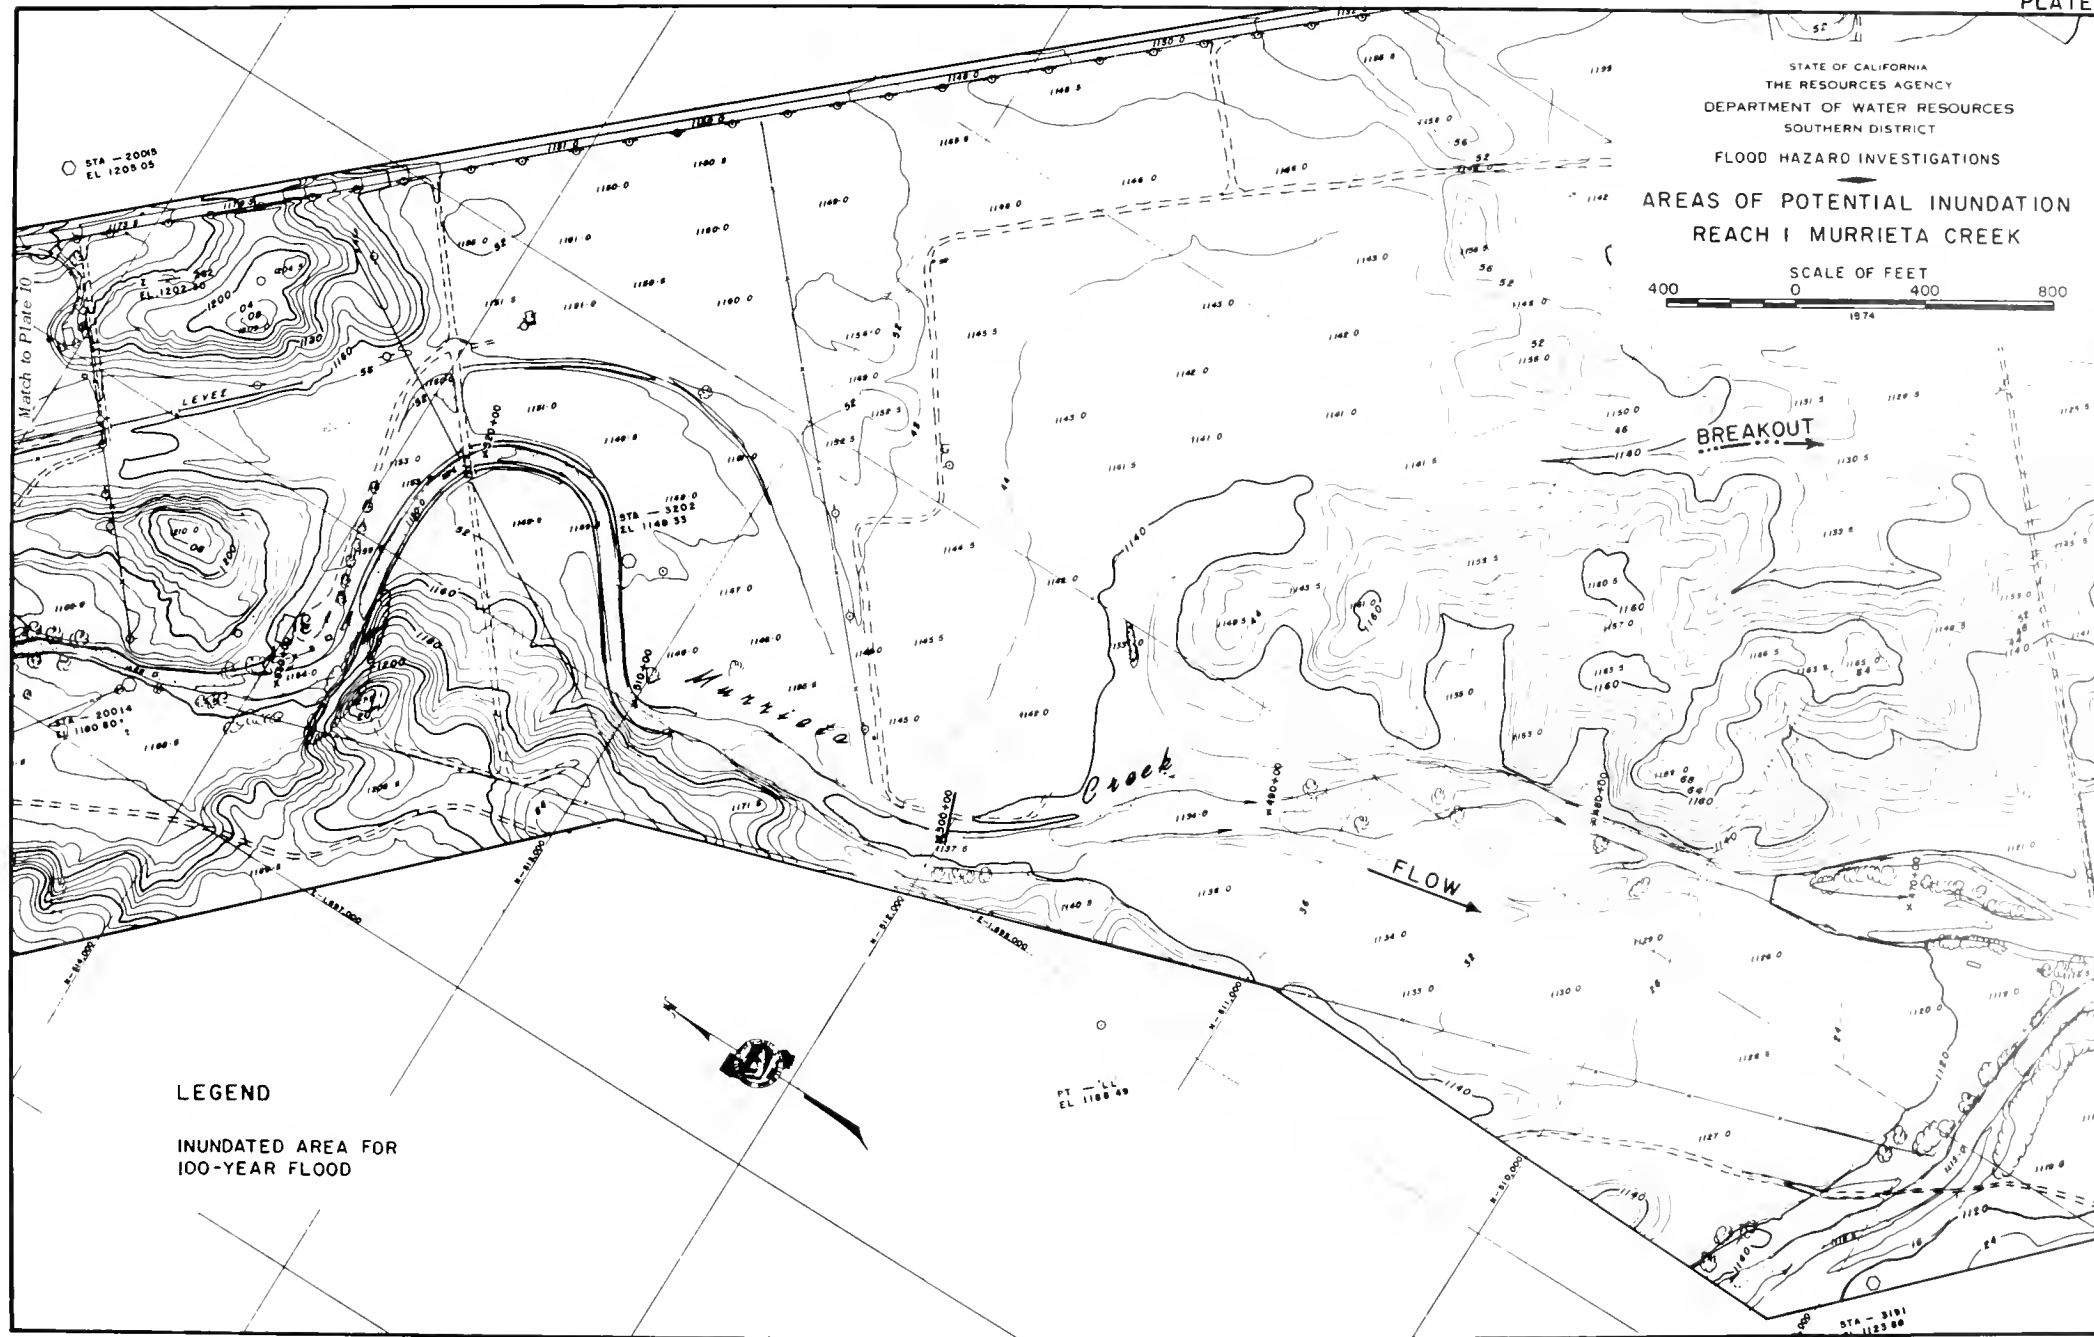
FLOOD HAZARD INVESTIGATIONS  
AREAS OF POTENTIAL INUNDATION  
REACH I MURRIETA CREEK

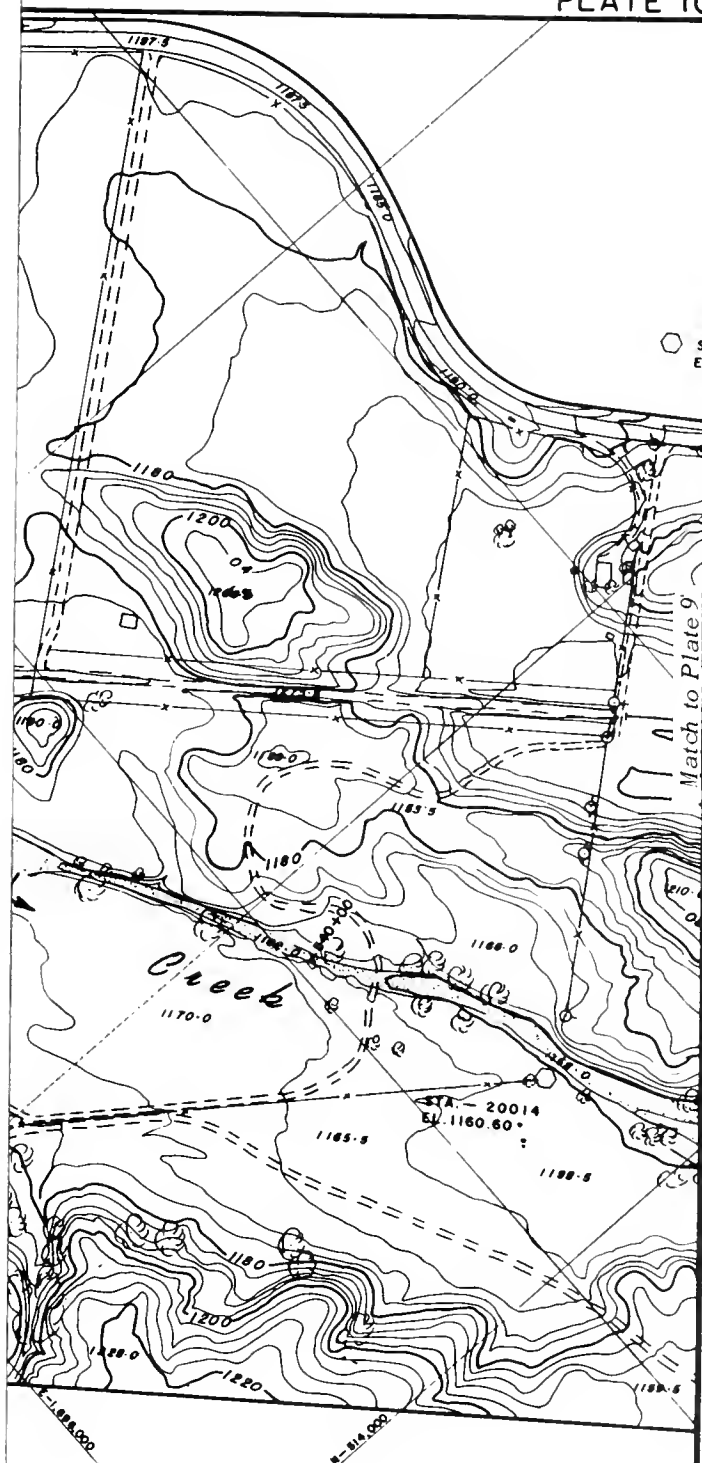
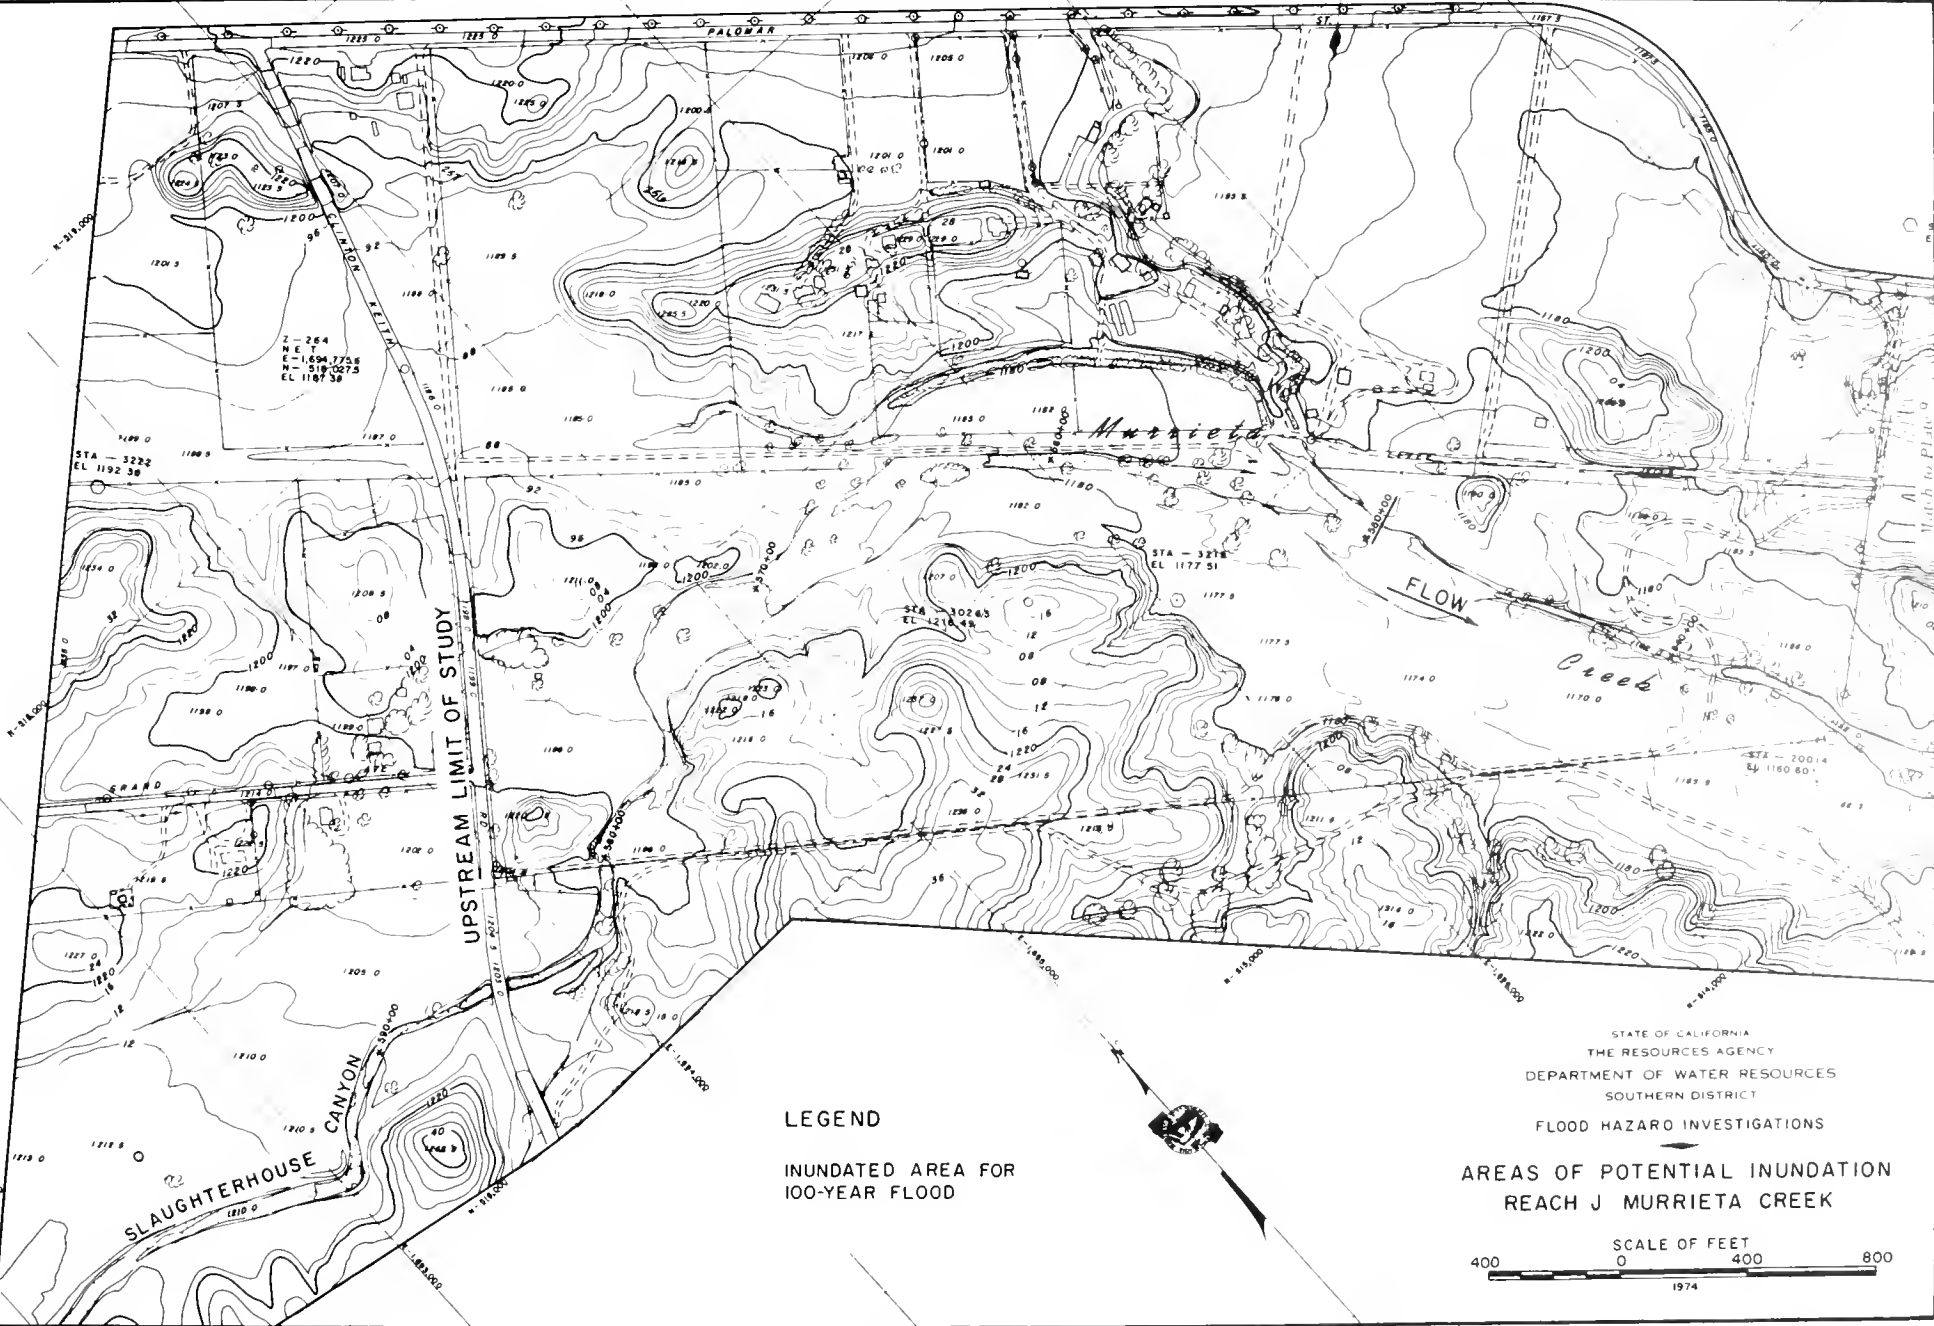
AREAS OF POTENTIAL INUNDATION  
REACH J MURRIETA CREEK
